NASA
Technical Memorandum 107228

Evaluation of a Vibration Diagnostic System for the Detection of Spiral Bevel Gear Pitting Failures

Prepared for the
Seventh International Power Transmission and Gearing Conference
sponsored by the American Society of Mechanical Engineers
San Diego, California, October 6-9, 1996

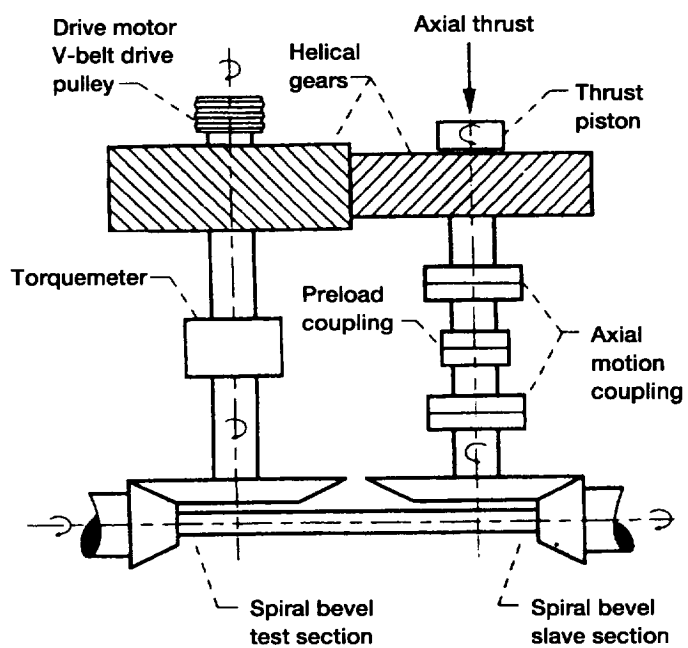
Figure 1.—Crosssection view of test facility.

The spiral bevel gear test rig used for the testing conducted herein is one of two such facilities at NASA Lewis Research Center. A sketch of the bevel gear test rig is shown in Fig. 1 and a cross-section of the test rig showing the main features is shown in Fig. 2. The bevel gear test rig is a closed-loop, torque-regenerative system with a closed loop capacity of 560 kW (750 hp). Power for the rig is provided by a 75 kW (100 hp) variable speed drive motor. The torque is controlled in the closed loop by moving a helical gear with a hydraulically actuated thrust piston. A torque

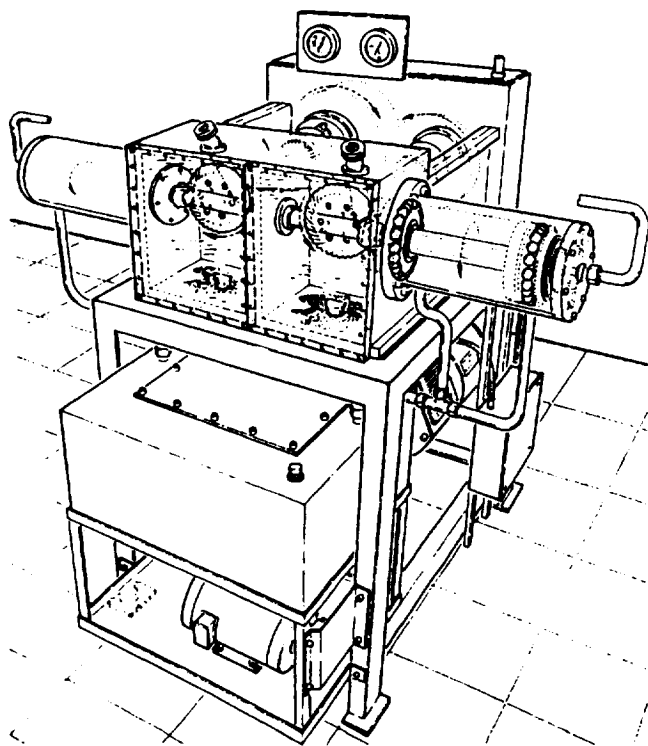
Figure 2.—Sketch of spiral bevel test facility.

As shown in Fig. 2 two sets of spiral bevel gears are tested simultaneously. The slave (right) side operates in a speed increaser mode, where the gear drives the pinion. The test (left) side operates in the intended fashion as a speed reducer. The gear ratio for the test rig is three to one with 12 teeth on the pinion and 36 teeth on the gear. A photograph of the test gears is shown in Fig. 3. The test hardware basic design parameters are given in Table I.

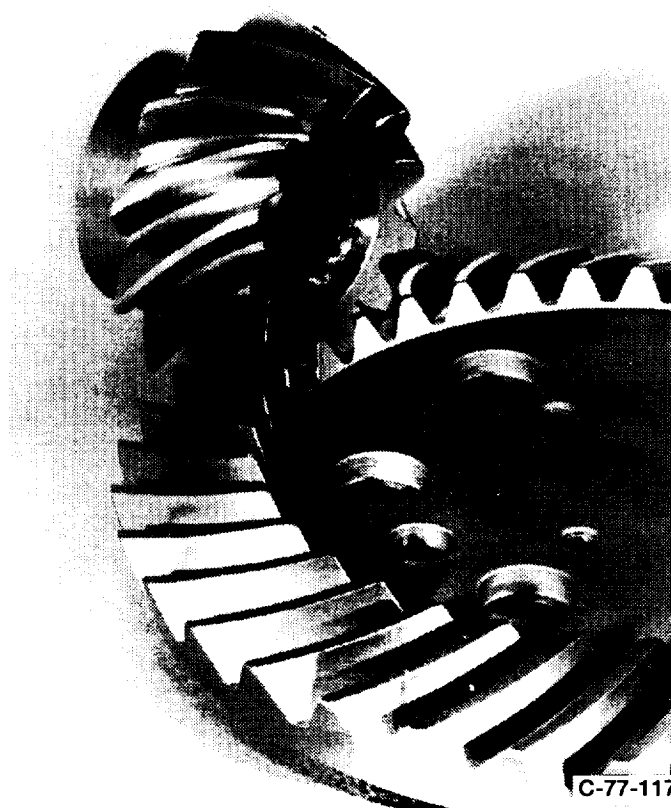
Figure 3.—Spiral bevel test gears.

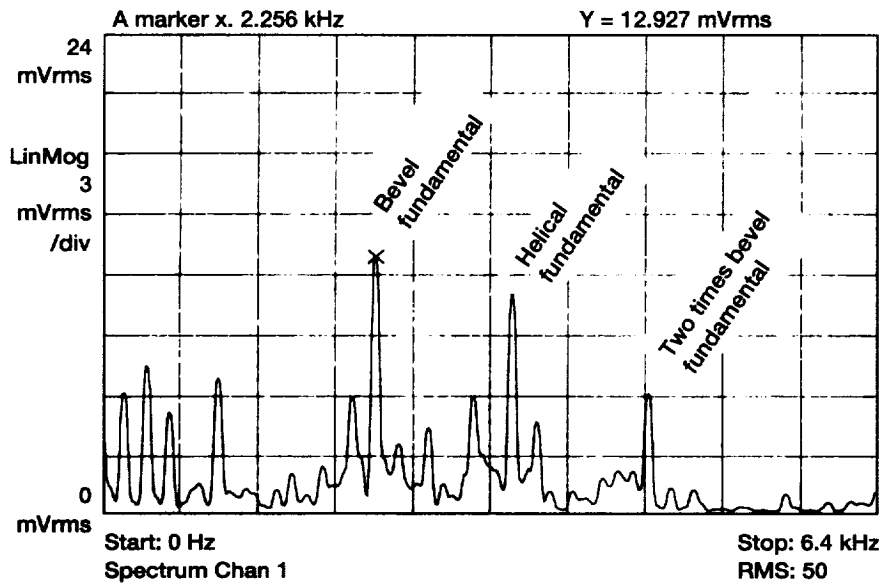
Figure 4.—Typical vibration spectrum from NASA Bevel Gear Rig Pinion speed 11 400 rpm, gear speed 3800 rpm, torque on gear shaft 938 N m (8300 lb/in.).

Accelerometer vibration measurements were taken on the bevel gearbox to find the best vibration accelerometer location, because vibration modes of the gearbox case can affect the gear vibration signal. The best location was found to be on the pinion bearing housing adjacent to the test gear. Figure 4 is a spectrum of the test gearbox showing the various vibration frequencies. The once per revolution of the pinion and the first and second harmonic of gear mesh frequency are clearly seen. The peak at approximately 1.5 times the pinion mesh frequency is the mesh frequency of the helical gears which have 55 teeth each.

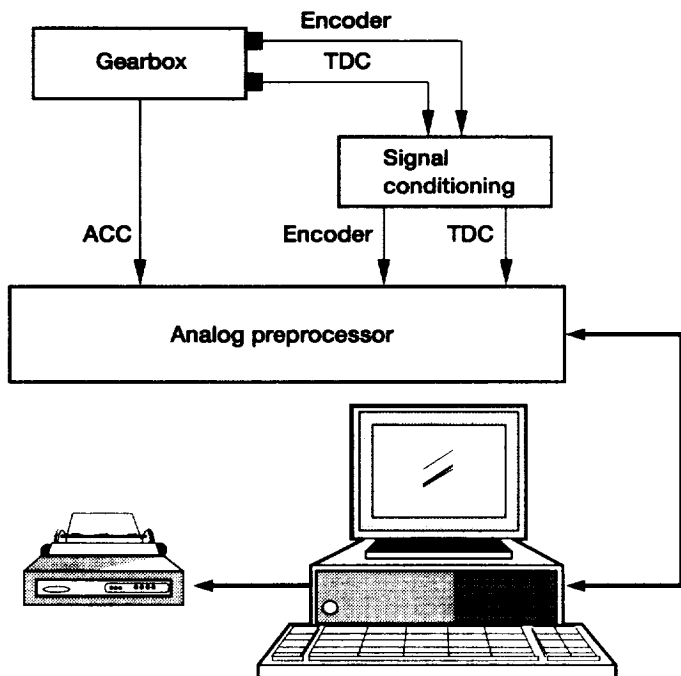
Figure 5.—Gear diagnostic system.

The diagnostic system used in this research program is a commercial gear diagnostic system. The system consists of a personal computer with an analog to digital board installed, a signal conditioning system, and a software package. A schematic of the system is shown in Fig. 5. The signal conditioning system includes a computer controlled tracking filter, computer controlled analog signal conditioning, a pulse rate multiplier/divider, and interfacing electronics. The software automatically sets and monitors the analog signal conditioning circuitry, performs the analysis and provides monitor displays of individual gear tooth vibration images. Gear condition status and alarms are issued when appropriate. The software can display current and past data in a variety of different formats. A flow chart of the system is shown in Fig. 6.

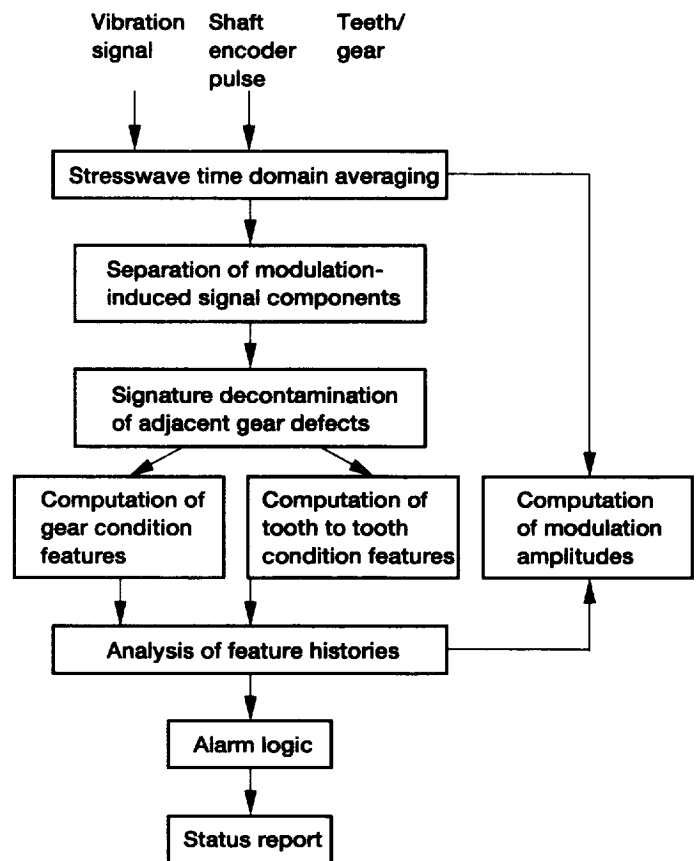
Figure 6.—Gear diagnostic system flow chart.

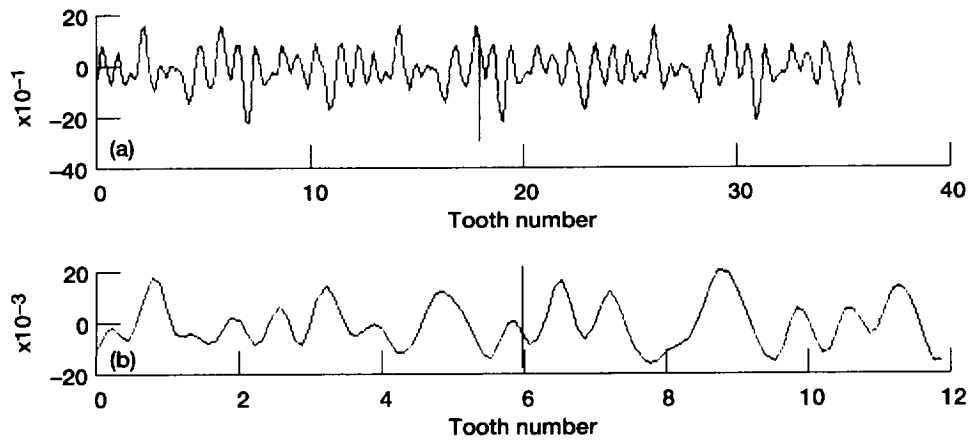
Figure 7.—Typical time synchronous average plots for spiral bevel test rig. Pinion speed 11 400 rpm, gear torque 938 N m (8300 lb/in.). (a) Gear baseband plot. (b) Pinion stresswave.

amplitude modulation function, or envelope, was then constructed. The envelope of the baseband vibration depicts the vibration pattern of each tooth on the gear, using the low frequency components of the signal. Figure 7 shows examples of gear baseband and pinion stresswave plots. The stresswave plots are generated from a high frequency band. This high frequency band was demodulated about a harmonic of the meshing frequency, then the amplitude modulation function was constructed. The envelope of the high frequency band is also known in this system as the gear stresswave. The stresswave depicts the vibration pattern of each tooth on the gear, using the high frequency components of the vibration signal. In many cases the resolution of the tooth meshing pattern is considerably better in the stresswave, than the baseband envelope. This is due to the decreased effect of the vibration transfer path dynamics at higher frequencies.

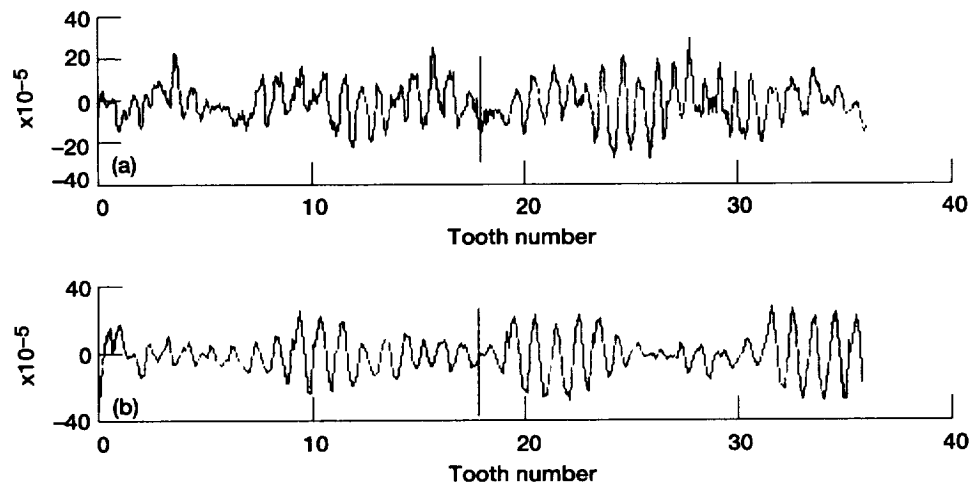
Figure 8.—Time synchronous average plots of gear for test run A. (a) Gear raw baseband plot. (b) Gear baseband envelope.

Figure 8(a) shows a plot of the gear pair raw baseband and Fig. 8(b) shows a plot of the gear pair base band envelope from the test A with the loose pinion hold down nut which ran a total of 122 hr. These plots were taken near the end of the test. The horizontal scale covers one revolution of the gear and shows the condition of each of the 36 teeth on the gear, while the vertical scale is the amplitude of the signal and indicates the intensity of the tooth load. Figure 8(a) shows an increase and decrease in amplitude at three locations during one revolution of the gear which indicates the eccentric condition of the pinion which is running at three times the speed of the gear. The 36 teeth on the gear can be seen in these plots.

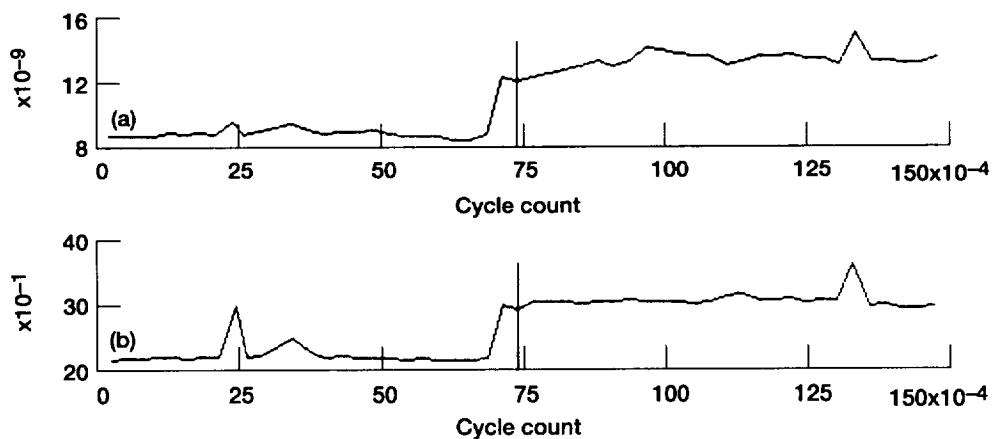
Figure 9.—Features plots of gear for test run A. (a) Total energy gear baseband envelope. (b) Kurtosis of gear baseband envelope.

Figures 9(a) and (b) shows some of the feature plots, produced by the diagnostic system for the test A with the loose nut. These plots show the various parameters from the start until the end of testing and are generated from the data shown in Figs. 8(a) and (b). These plots show the total energy of the gear base band envelope (Fig. 9(a)) and kurtosis of the gear raw baseband (Fig. 9(b)). From these figures it appears that something happened approximately half way through the test, however there were no indications of a failure in the time averaged vibration plots at this time. Near the end of the test these feature plots still indicate that something has happened. The time averaged vibration plots show a three cycle wave giving a change in amplitude with each revolution of the pinion. This condition was caused by a loose pinion nut that allowed the pinion to run in an eccentric condition thereby producing the three cycle amplitude variation per gear revolution.

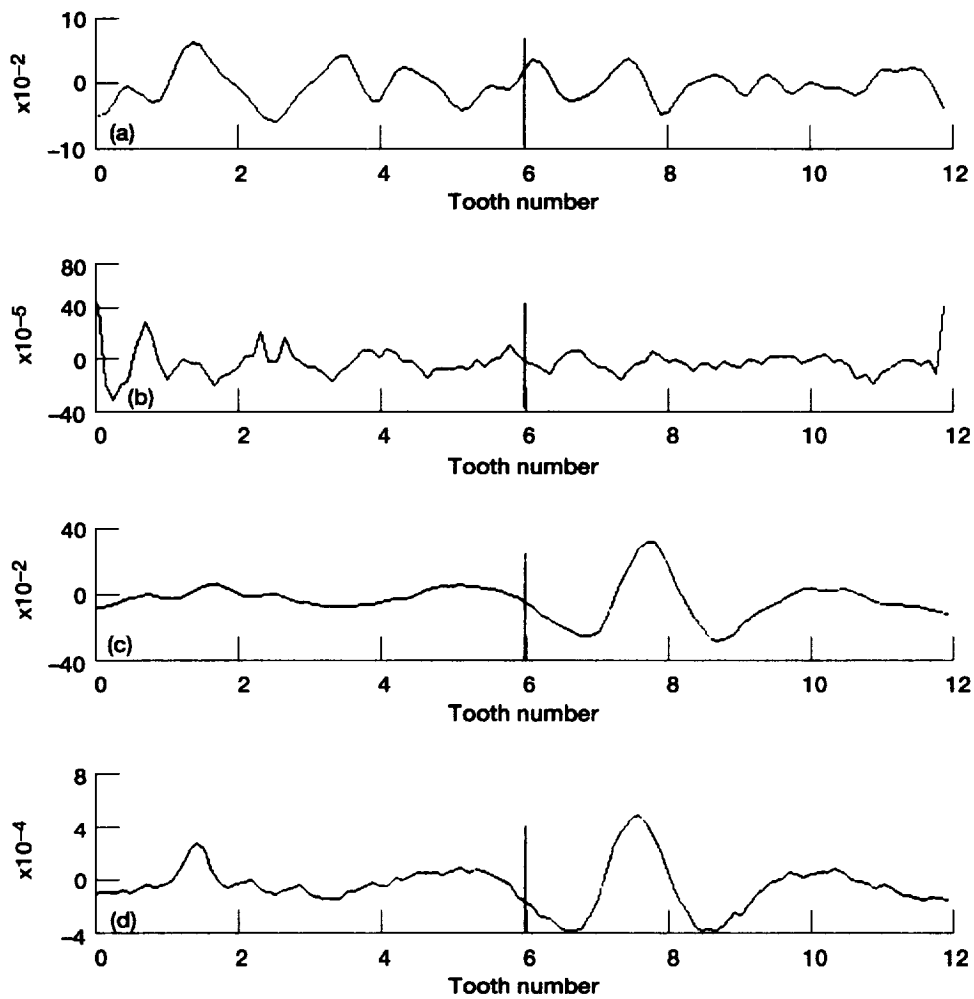
Figure 10.—Time synchronous average plots of pinion for test run B. (a) Pinion stresswave start of test. (b) Pinion baseband envelope start of test. (c) Pinion stresswave end of test. (d) Pinion baseband envelope end of test.

Figures 10(a) to (d) shows the time averaged plots of the pinion stresswave and the pinion base band envelope from test B. Plots 10 a and b were taken at the start of the test and plots 10 c and d were taken at the

end of the test. Near the end of the test the pinion stresswave and pinion baseband envelope show an increased amplitude for one tooth (tooth number 8). This indicates an increased loading for this tooth.

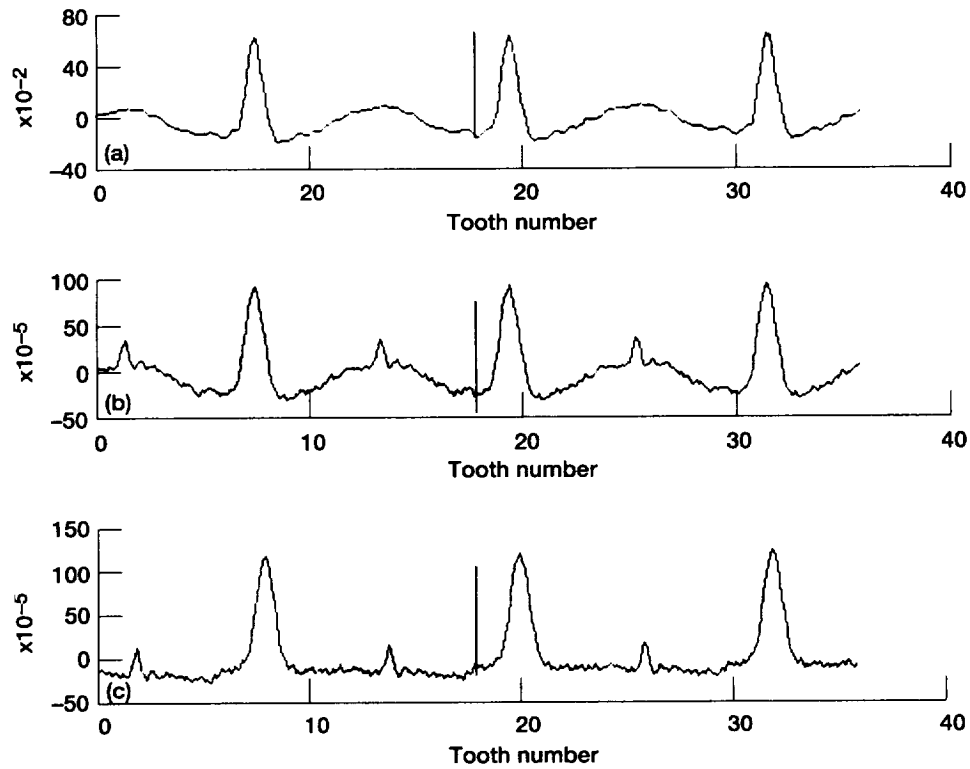
Figure 11.—Time synchronous average plots of gear for test run B. (a) Gear stresswave. (b) Gear baseband envelope. (c) Hunting tooth baseband envelope.

Figures 11 (a) to (c) are the time averaged plots of the gear stresswave, gear baseband envelope, and hunting tooth baseband envelope for test B. Each of these curves shows the gear teeth at locations 8, 20, and 32 to have a very high amplitude compared to the other teeth on the gear. These are exactly 12 teeth apart which is the number of teeth on the pinion. This increased amplitude of the three teeth on the gear is a result of the surface fatigue damage of one tooth on the pinion shown in Fig. 12.

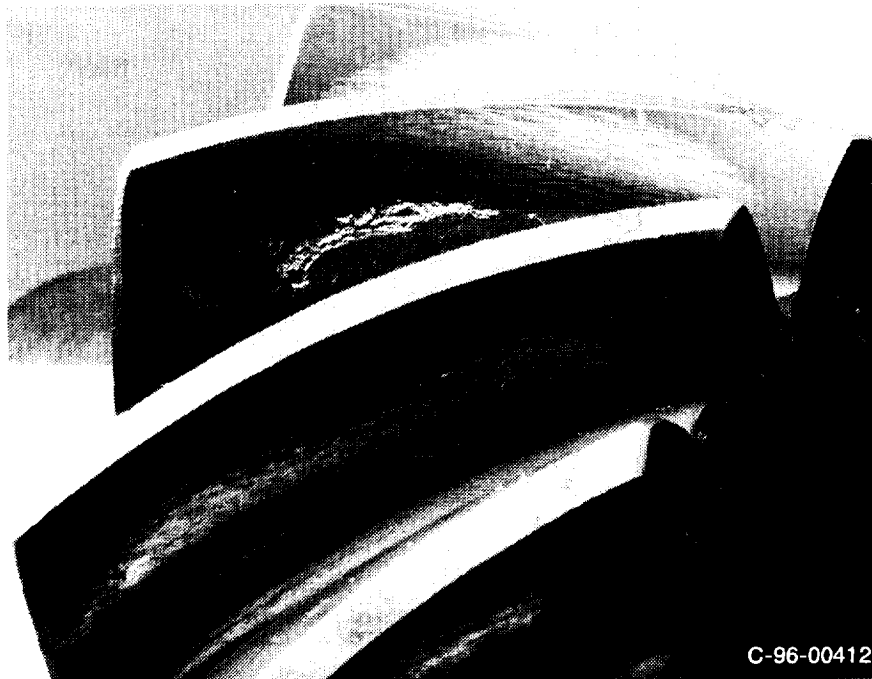
Figure 12.—Pinion tooth fatigue spall test run B.

Figure 13 shows six of the 14 feature plots, for test B. These plots were generated from the data shown in Figs. 10 and 11. Figures 13(a) to (c) are the (a) peak residual ratio, (b) kurtosis and (c) total energy of the pinion stresswave. Figures 13(d) to (f) are (d) the peak residual and (e) total energy of the gear baseband envelope and (f) the kurtosis of the gear stresswave. From these figures it is clear that not much damage occurred until the last 15 percent of total test time. After about 85 percent of total test time all of the above indicators began a steady and continuing increase in amplitude until the test was stopped. The pinion time averaged plots, Figs. 10(c) and (d) show that one tooth (tooth number 8) on the pinion was producing a higher dynamic load than the other teeth. This tooth was found to have fairly sizable fatigue spall as shown in Fig. 12.

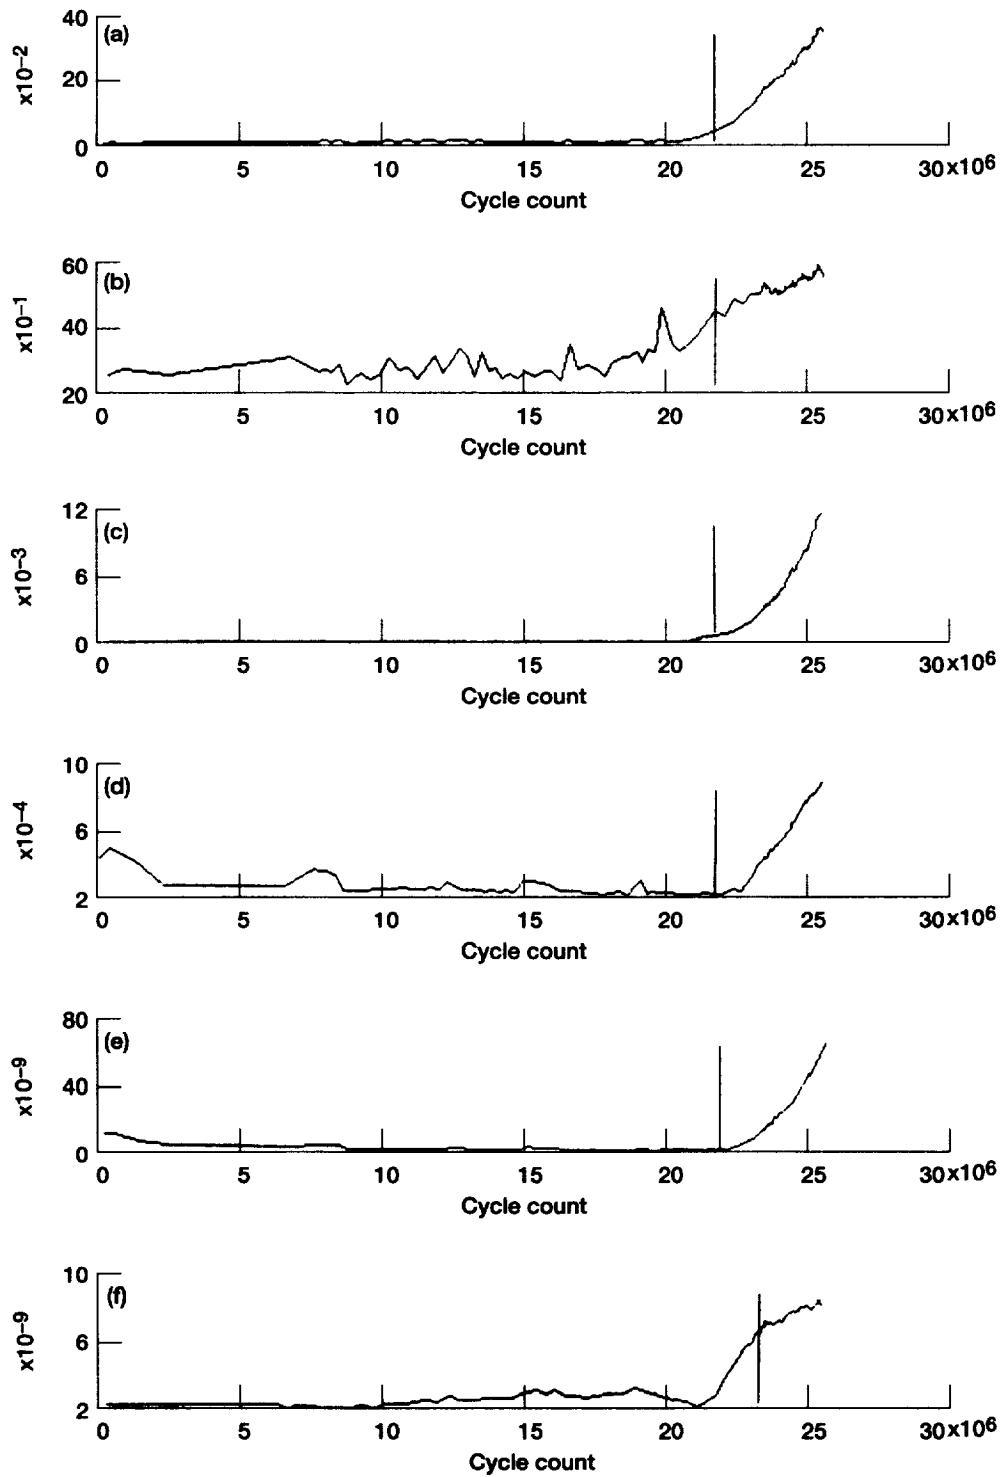
Figure 13.—Features plots for test run B. (a) Peak residual pinion stresswave. (b) Kurtosis pinion stresswave. (c) Total energy pinion stresswave. (d) Peak residual gear baseband envelope. (e) Total energy gear baseband envelope. (f) Kurtosis gear stresswave.

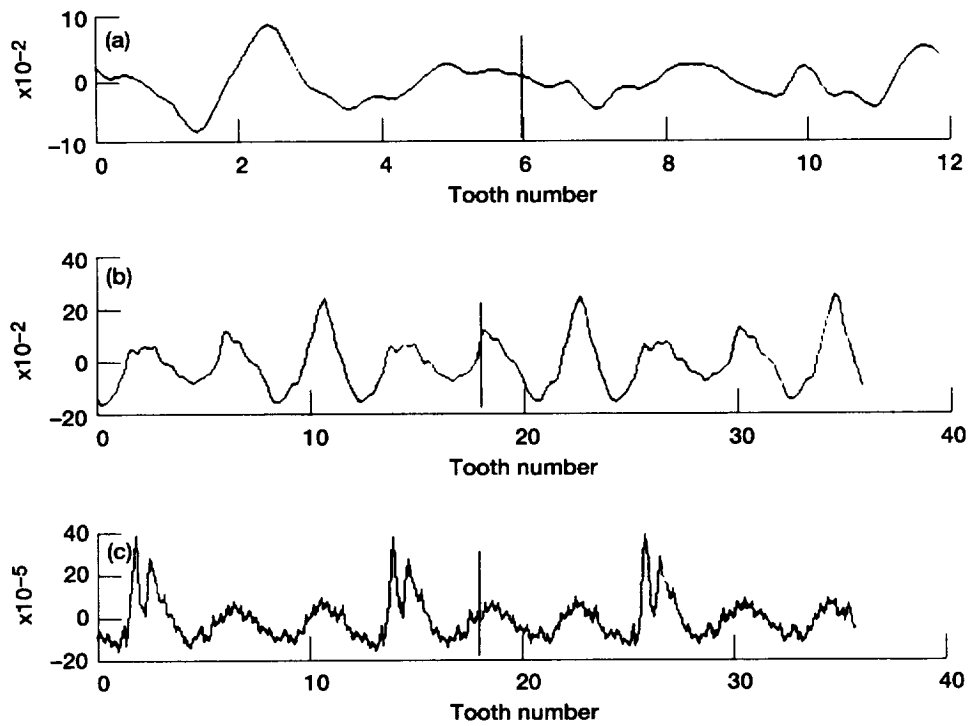
Figure 14.—Time synchronous average plots of test run C. (a) Pinion stresswave. (b) Gear stresswave. (c) Hunting tooth baseband envelope.

Another gear test run C completed a total of 527 hr and had some fatigue damage on one tooth. The plots for the time averaged pinion stresswave, gear stresswave and hunting tooth baseband envelope are shown in Figs. 14(a) to (c) respectively. A signal from each individual tooth cannot be seen on these figures, however these figures show an increase in amplitude for one area of the pinion near tooth number 3 and for three areas of the gear. This indicates that one location on the pinion is contributing to an increase in dynamic load. Figure 15 shows the fatigue spalls on the pinion and gear for test C.

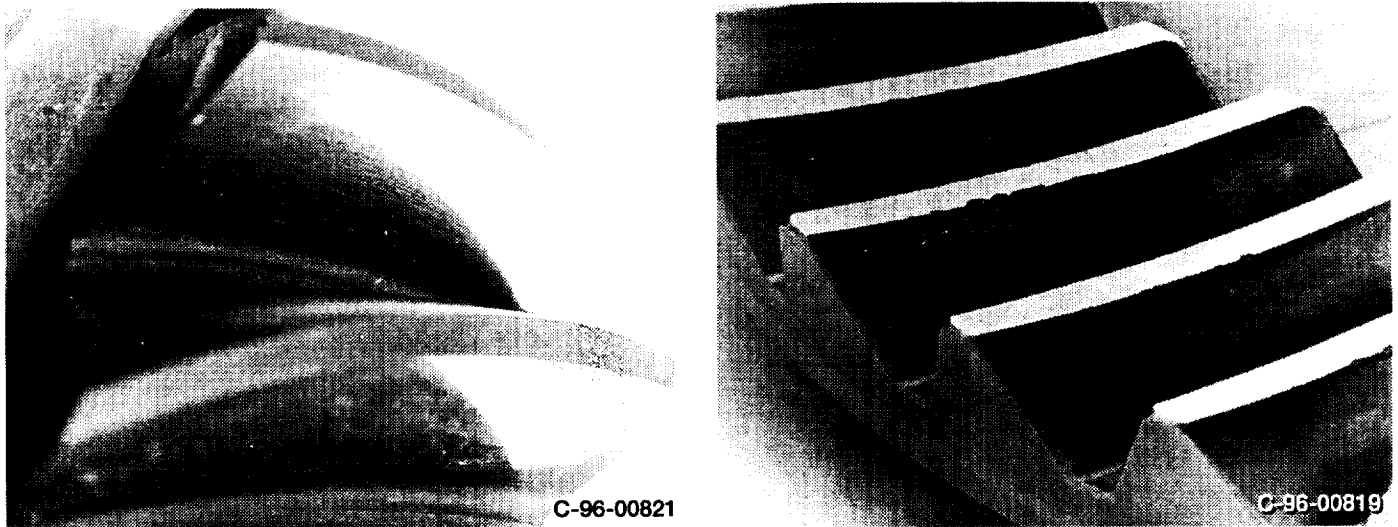
Figure 15.—Gear and pinion fatigue spall for test run C.

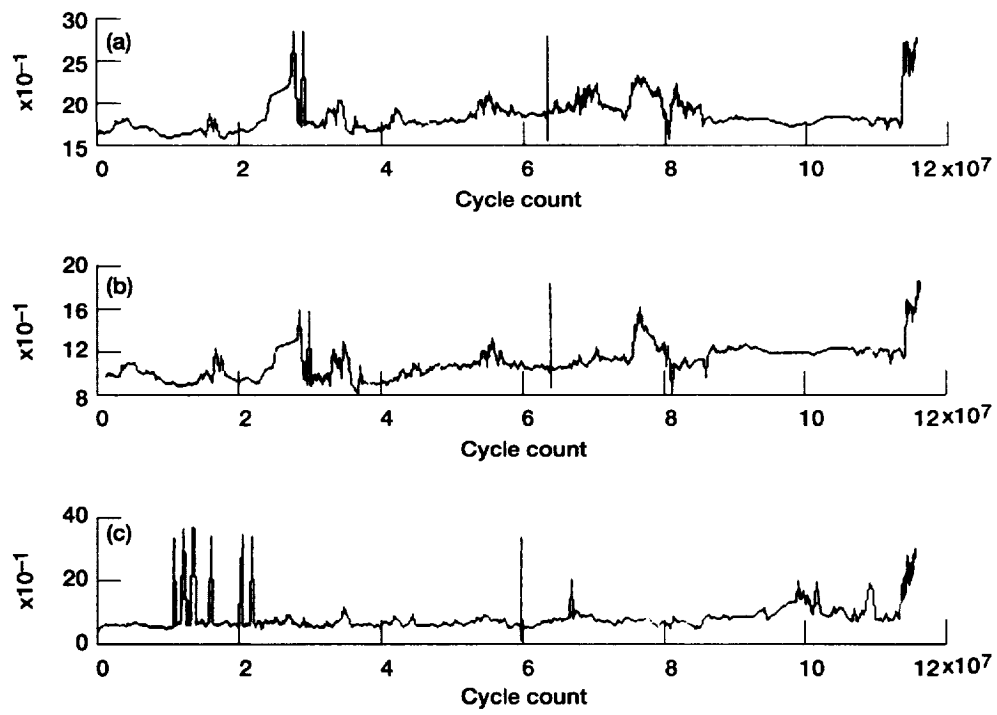
Figure 16.—Features plots of test run C. (a) Kurtosis gear stresswave. (b) Peak ratio gear stresswave. (c) Peak residual ratio baseband envelope.

Figures 16(a) to (c) are the feature plots for test C and show the kurtosis and peak ratio for the gear stresswave and the peak residual ratio for the gear base band envelope. These plots show an increase in these parameters near the end of the test C and are an indication of increased vibration activity caused by the pinion fatigue spall. The earlier peaks were probably the result of stopping and starting the test.
